Standish Ericsson Alleyway Retrofit

Monitoring Report

By: Metro Blooms
Prepared for
Minnehaha Creek Watershed District
and
Hennepin County

December 2018

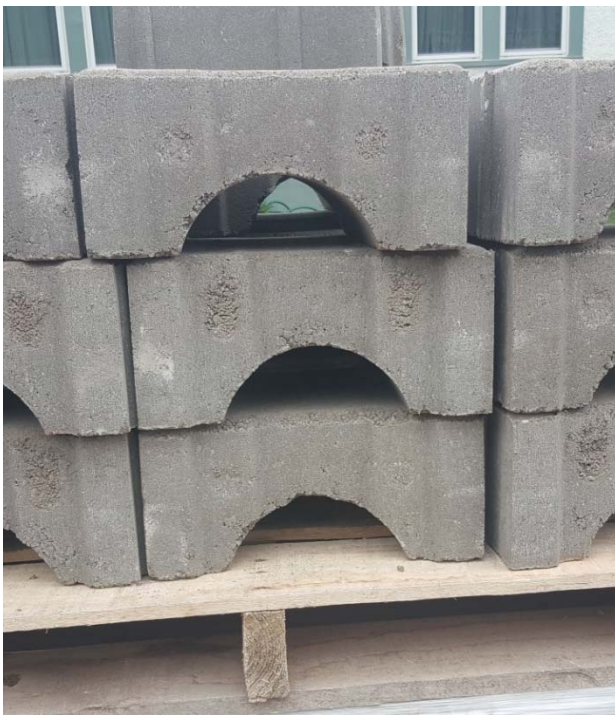
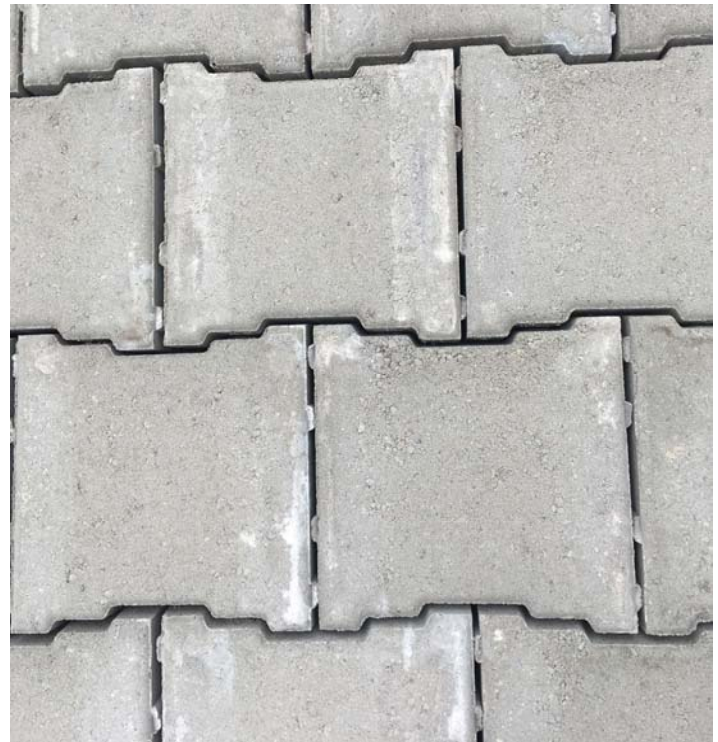
PaveDrain permeable pavers, distributed by Brock White

the Columbia Heights library, and in the parking lot at Ramsey Washington Metro Watershed District, but no stormwater runoff monitoring of these practices had been performed to our knowledge. PaveDrain pavers are highly durable, have a built-in arch system to increase storage capacity, and don't require aggregate between joints, leading to easier maintenance. The alley is sloped, requiring a terraced PaveDrain system design (see cross section below).

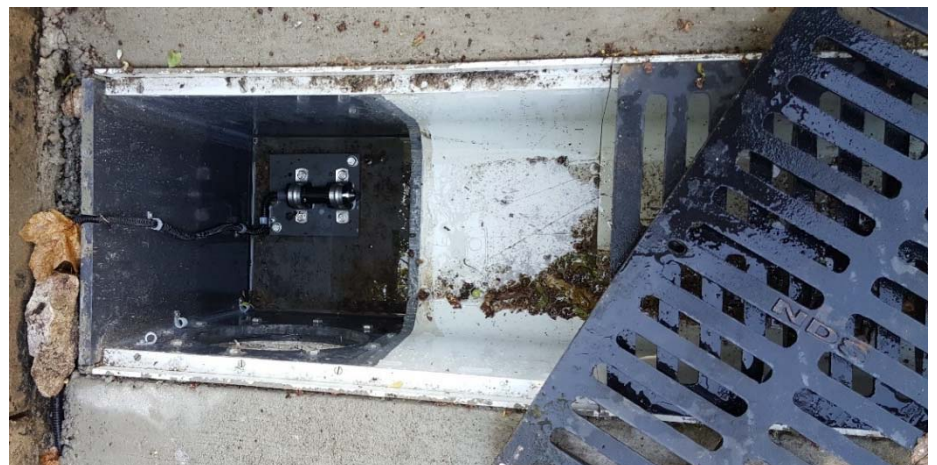
Pressure transducer mounted in bottom a sump box in a modified trench drain

The pressure transducer mounted at the bottom of the sump box measures the water depth every minute. Using water depth data with the geometry of the weir, it is possible to determine the volume of water passing through the device over time measured in Cubic Feet per Second (CFS).

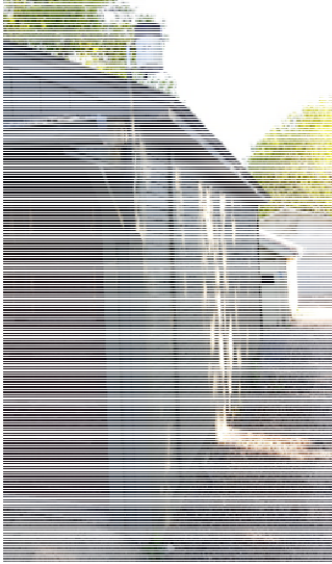
Tip bucket rain gauge mounted on garage

The rain gauge measures precipitation over time (intensity) in hundredths of an inch. It was installed at the southeast corner of the 3845 21st Ave S garage at a location clear of trees or other overhead obstruction.

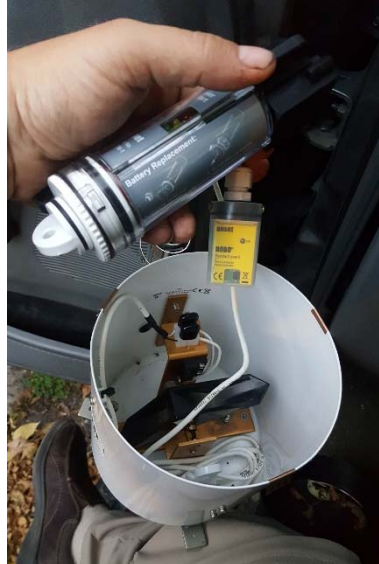
Tip bucket rain gauge and HOBO waterproof shuttle

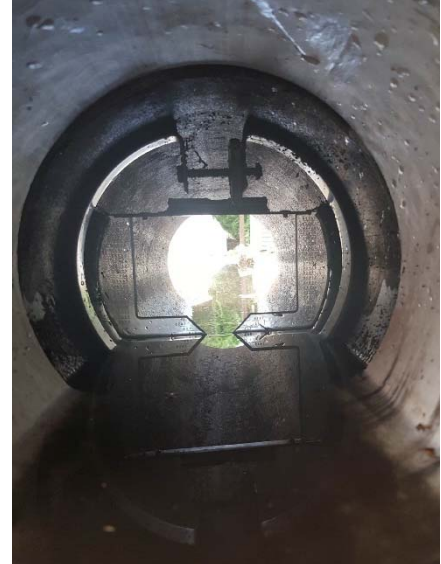
V-notched weir mounted inside 8-inch steel drain pipe

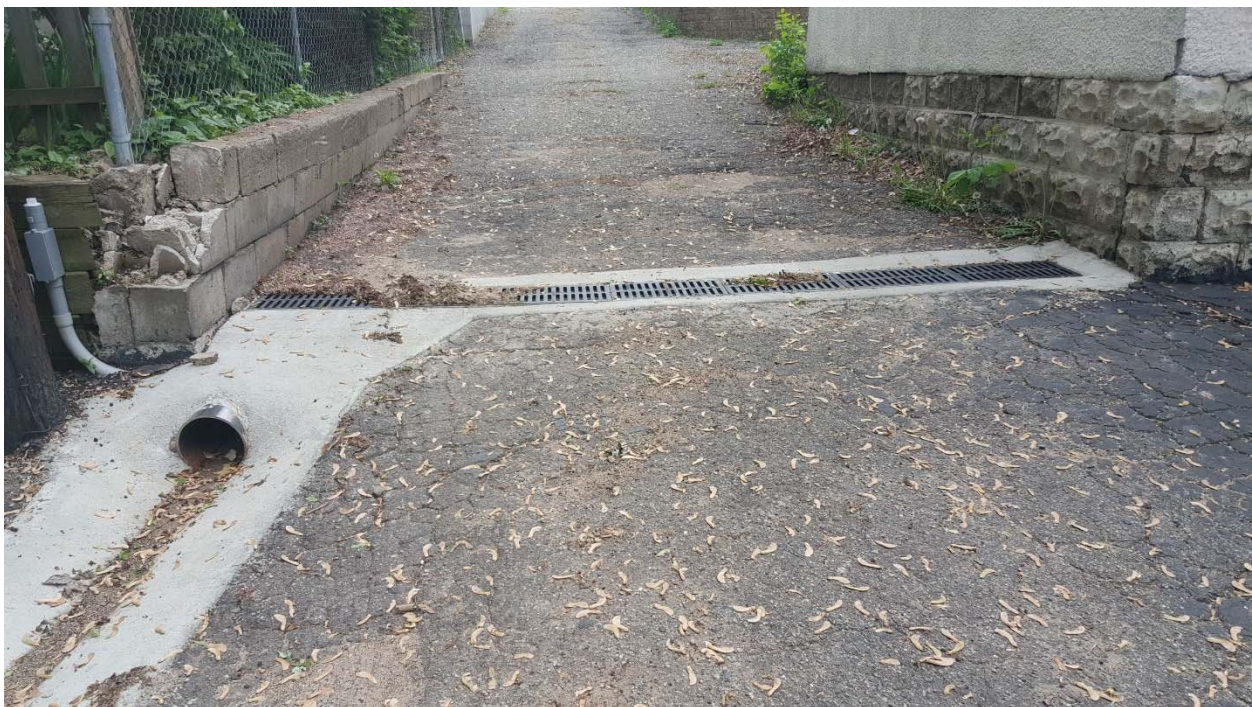
Trench drain with 8-inch steel drain pipe and flow data logger, 2017

The trench drain and rain gauge were installed in early May 2017. Monitoring of control runoff conditions began in late May and continued through 2017 until the first freeze in October. The PaveDrain permeable pavement system was installed in May 2018. Monitoring and data collection continued through October 2018.

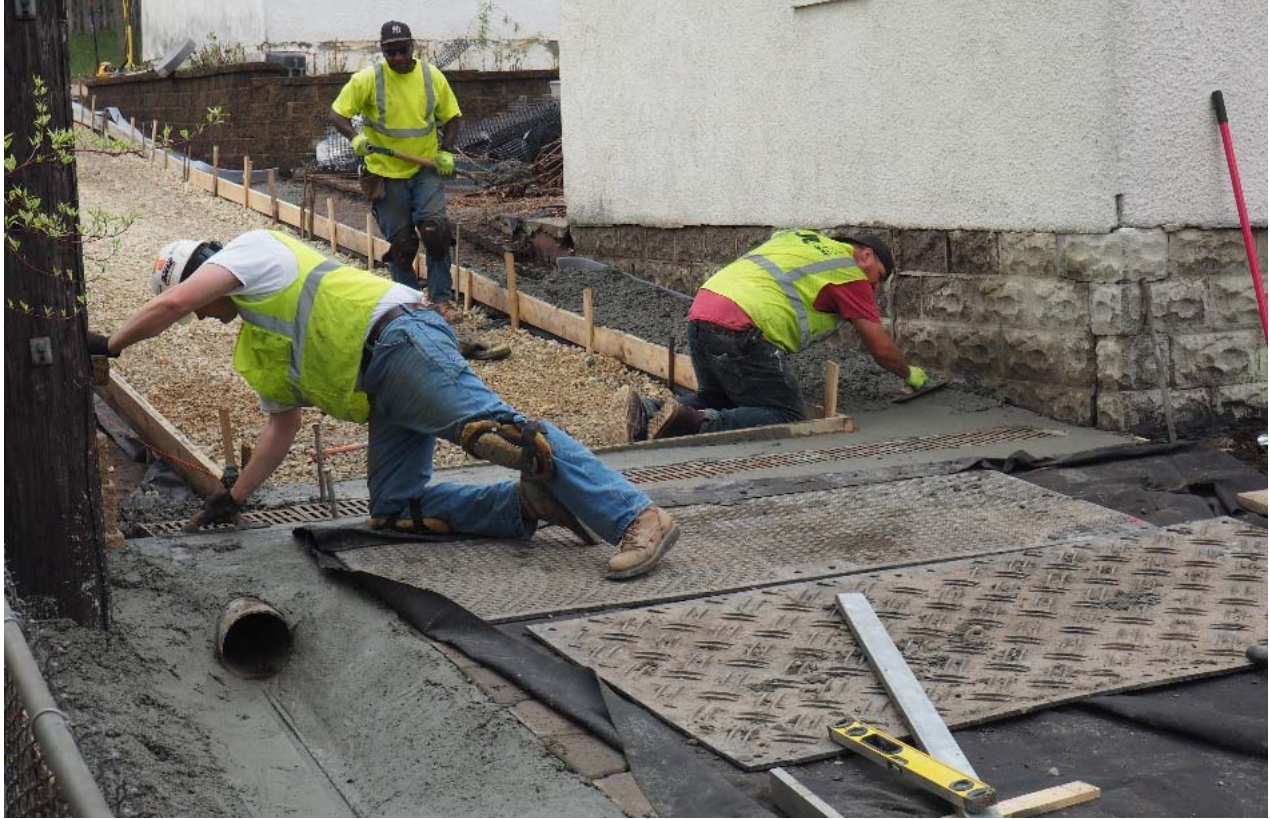
Concrete pour and trench drain / 8-inch steel drain pipe and re-installation in same location as 2017

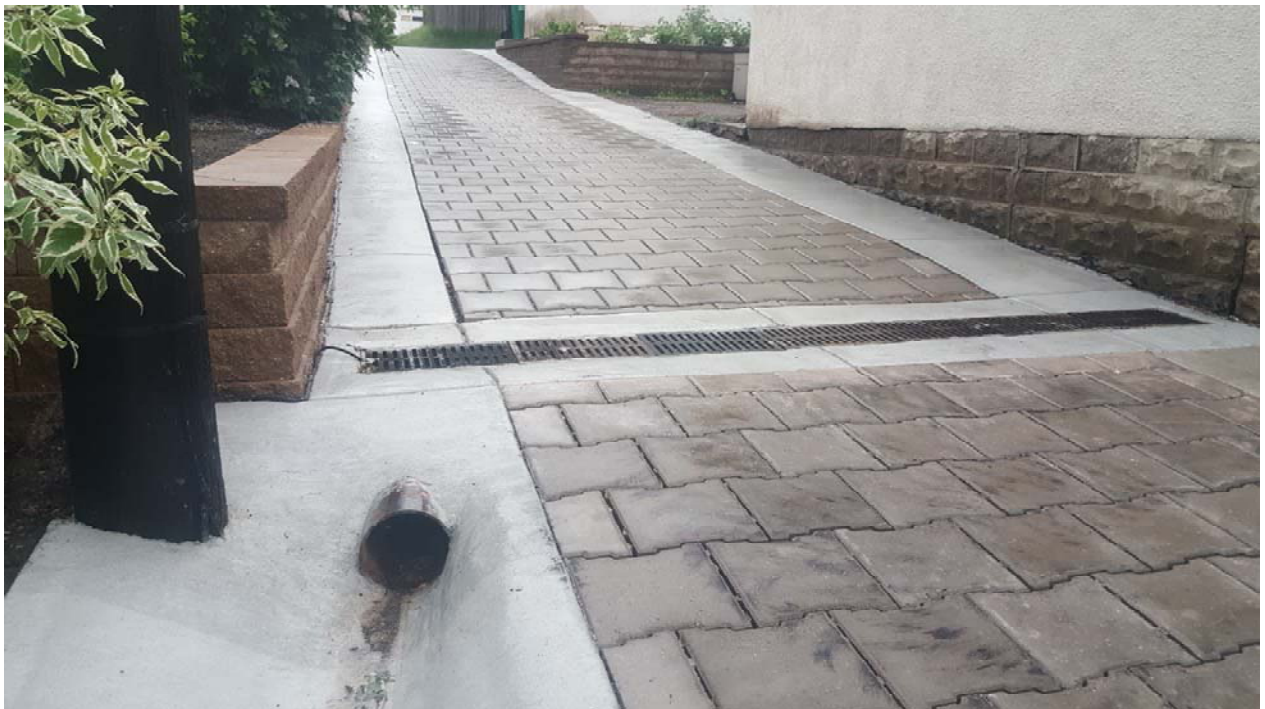
Complete PaveDrain alley, May 2018 Construction by JL Theis. Inc.

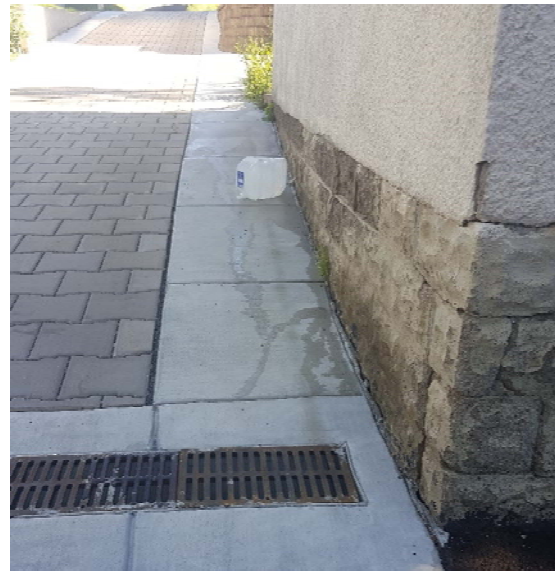
Field test showing runoff draining directly to the trench drain

After construction of the permeable pavement, it was observed that the concrete ribbon strip between the pavers and garage at 3849 21st St S was not cross-sloped toward the pavers as anticipated. This caused runoff to flow directly downhill, perpendicular to the trench drain. This resulted in approximately 185 square feet of impervious surface (1/2 the garage roof and concrete) still draining directly to the channel drain after the permeable pavement was installed. This untreated runoff skewed the results, lowering the measured effectiveness of the pavers.

WinSLAMM models the runoff this surface generates from a 1.1"/24hr storm at about 12.67 cubic feet of runoff. This would account for a significant amount of runoff measured by the flow data logger in the 2018 post-permeable paver installation data set.
