**ASSESSMENT OF
INFILTRATION PERFORMANCE
AND MAINTENANCE OF
PAVEDRAIN PAVEMENTS**
FOR TWO APPLICATIONS IN LOUISVILLE, KY

Hamidreza Kazemi, PhD Candidate
Thomas Rockaway, Ph.D., P.E.
Josh Rivard, MUP
Center for Infrastructure Research
Civil and Environmental Engineering Department
University of Louisville

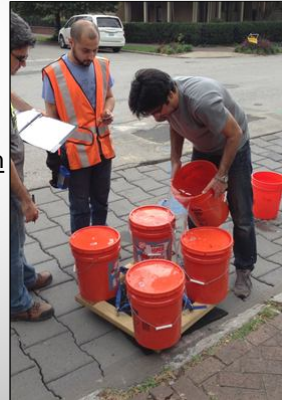
✓ Manual Surface Infiltration Measurements

Modified ASTM C1701

Four Locations Along the Curb Side

Tests were repeated periodically and within one week before and after each maintenance treatment

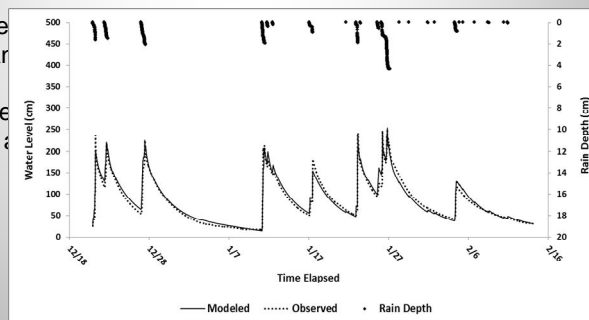
Based on the piezometer data a model was developed

The developed model predicts the ideal performance of the control and compares it to recorded data

This assessment technique is used to quantify the infiltration capacity and effectiveness of maintenance treatments

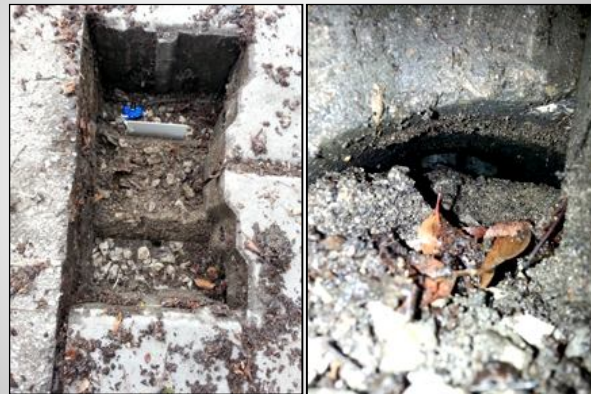
❖ Concerns with Airjet method

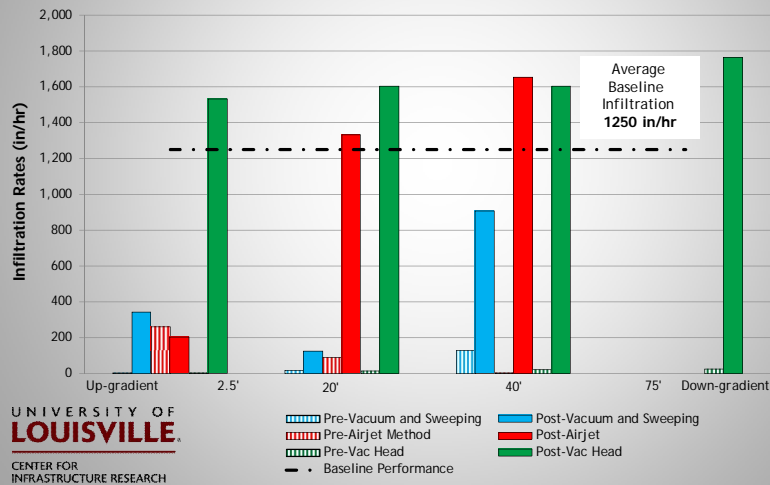
❖ Surface Infiltration Tests Results (Control 19G)

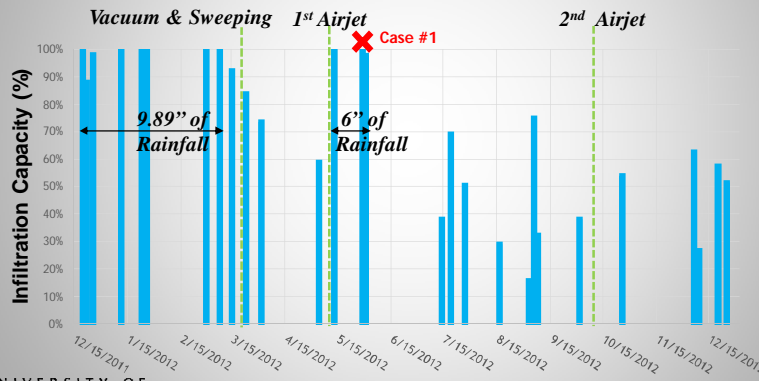
❖ Developed Model Output (Control 19G)

Each maintenance is identified with a vertical green line.

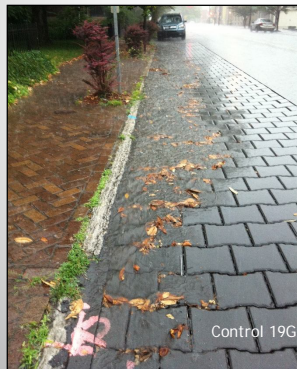
CASE #1: STORM EVENT 5/29/12

- ✓ Rainfall depth: 2.26 in
- ✓ Duration: 7 hours
- ✓ Max Intensity: 1.20 in/hr
- ✓ Controls 19G & 19H cumulatively captured: 16,181 Gallons
- ✓ The only time that control 19H flooded
- ✓ 19G captured all runoff

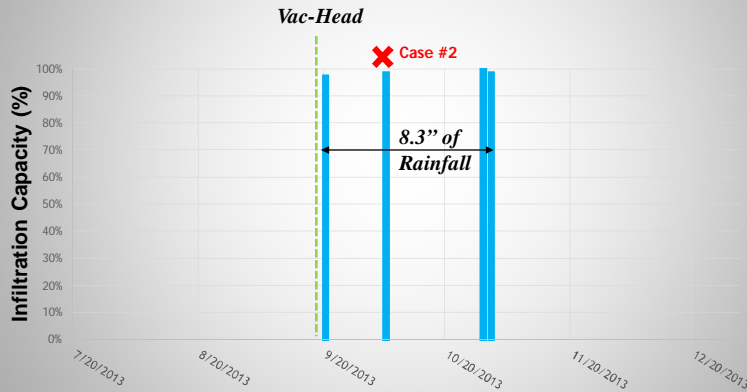
❖ Developed Model Output (Control 19G)

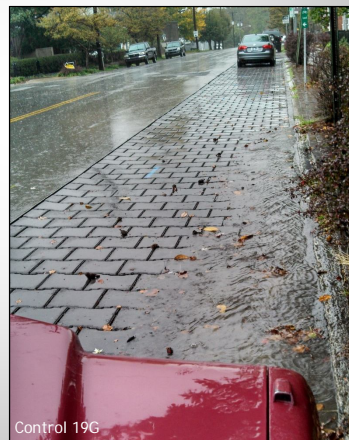
CASE #2: STORM EVENT 10/5/13

- ✓ Rainfall depth: 4.47 in
- ✓ Duration: 35 hours in/hr
- ✓ Max Intensity: 1.68
- ✓ Controls 19G captured all surface runoff from its drainage area
- ✓ Volume Captured: 15,700 Gallons
- ✓ Control 19G was cleaned with Vac-Head method 17 days ago

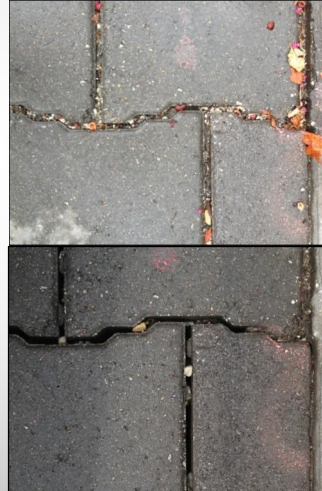
- ❖ Infiltration Capacity Can be Restored!
- ❖ Type of Maintenance treatment is important
- ❖ Pre & Post Maintenance Vac-Head Method ➔
